1. Project Name: Kawaihae Deep Draft Harbor
2. Date of Inspection: May 3, 2005
3. Inspection Personnel:

KAWAIHAE DEEP DRAFT HARBOR, HAWAII

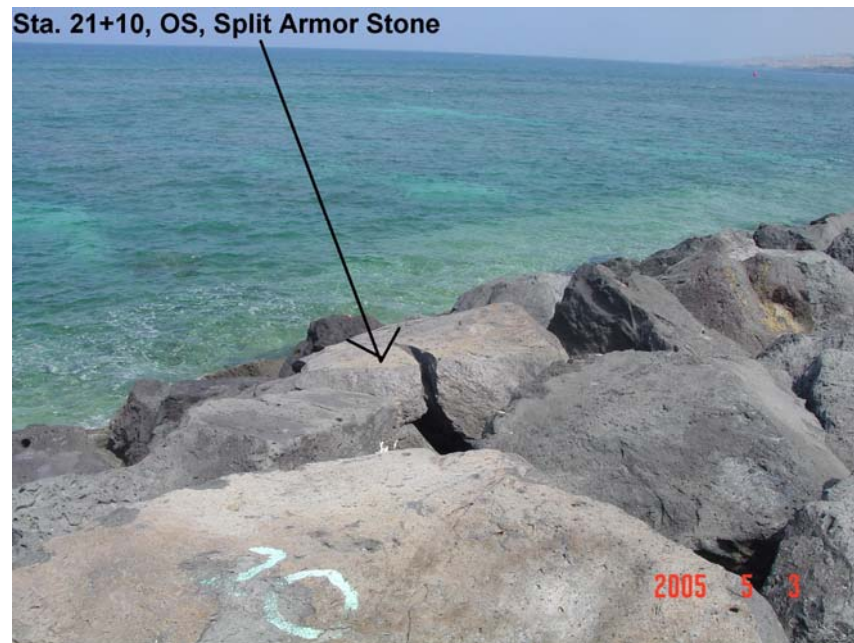
ss. Sta. 20+10, OS, three fractured armor stone (two OS and one HS).

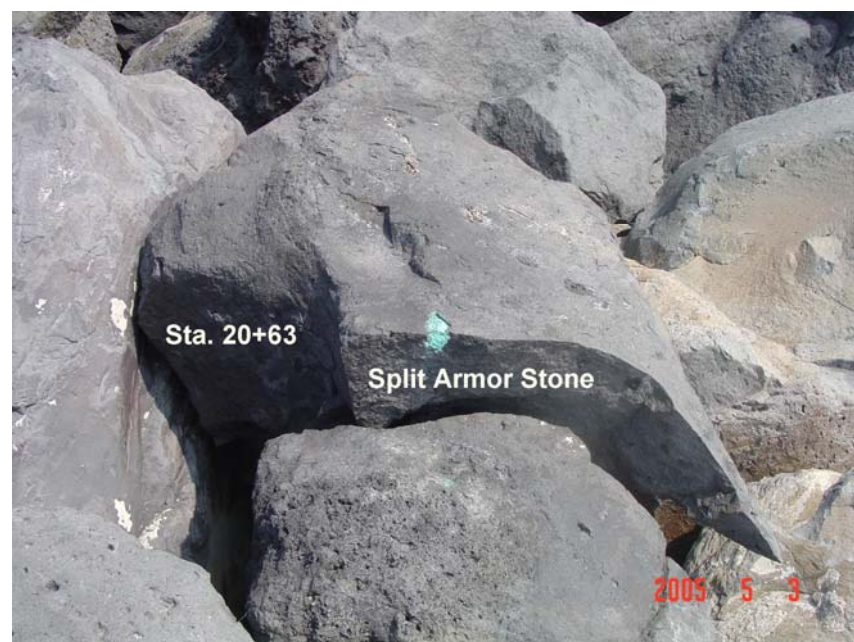
tt. Sta. 20+63, CL, cracked armor stone.

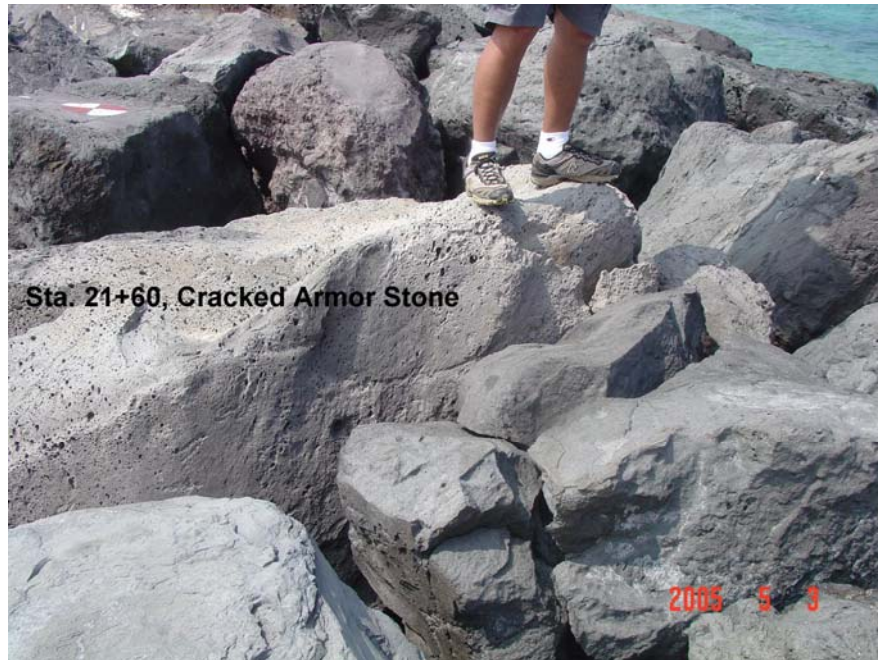
uu. Sta. 21+60, cracked armor stone.

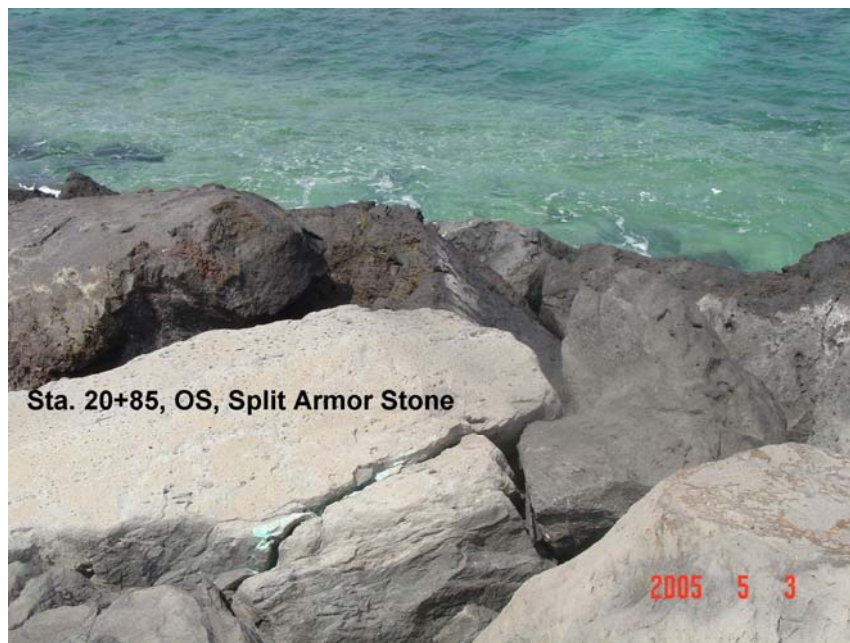
vv. Sta. 20+85, OS, cracked armor stone and minor settling and bridging.

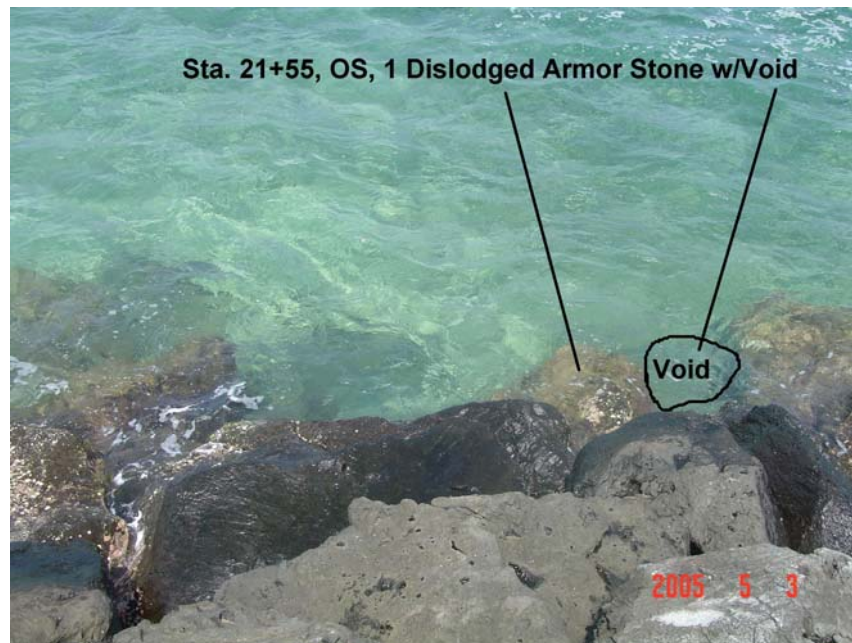
ww. Sta. 21+55, OS, 1 ea. dislodged armor stone and void.

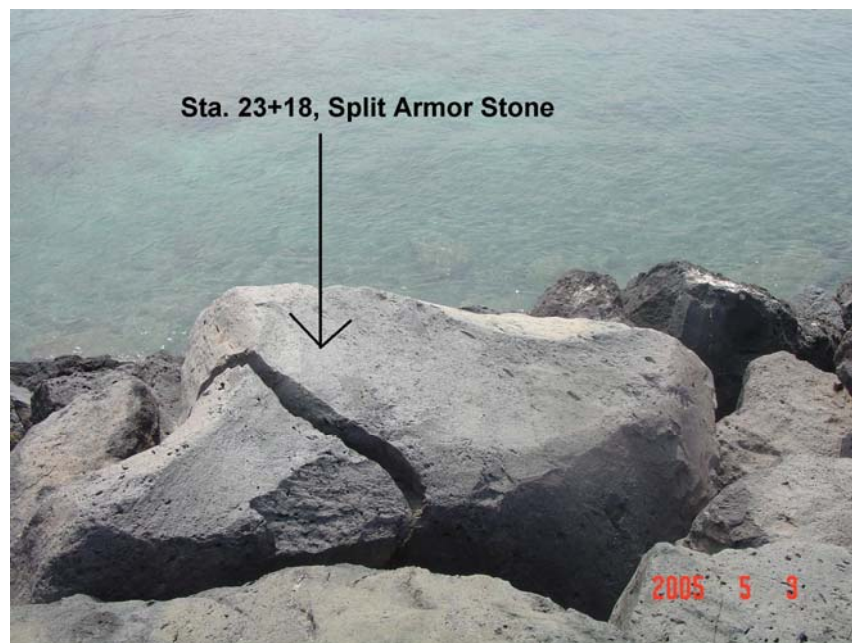
xx. Sta. 23+18, HS, cracked armor stone and additional settling this year.

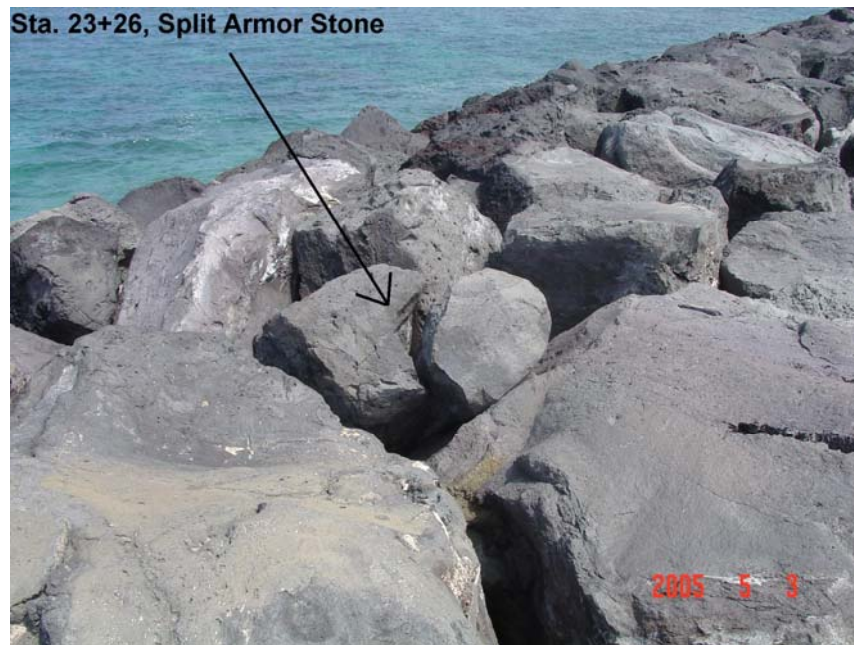
yy. Sta. 23+26, CL, cracked armor stone.

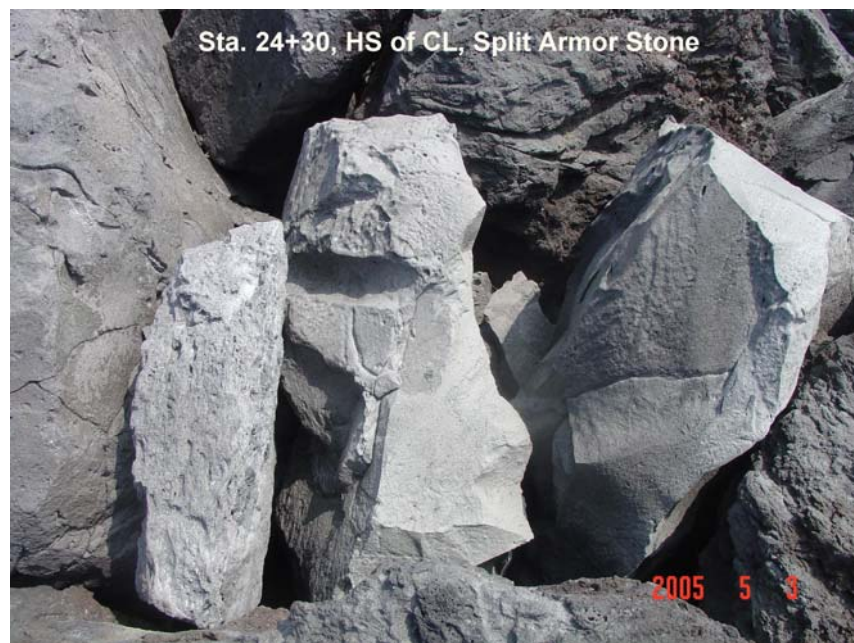
zz. Sta. 24+30, HS of CL, new split armor stone this year.

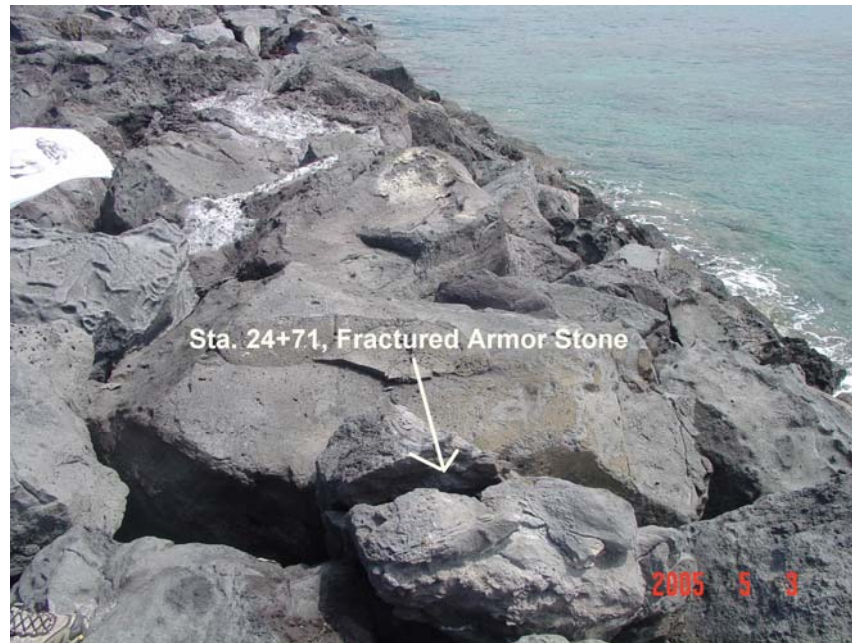
aaa. Sta. 24+71, CL, cracked armor stone.

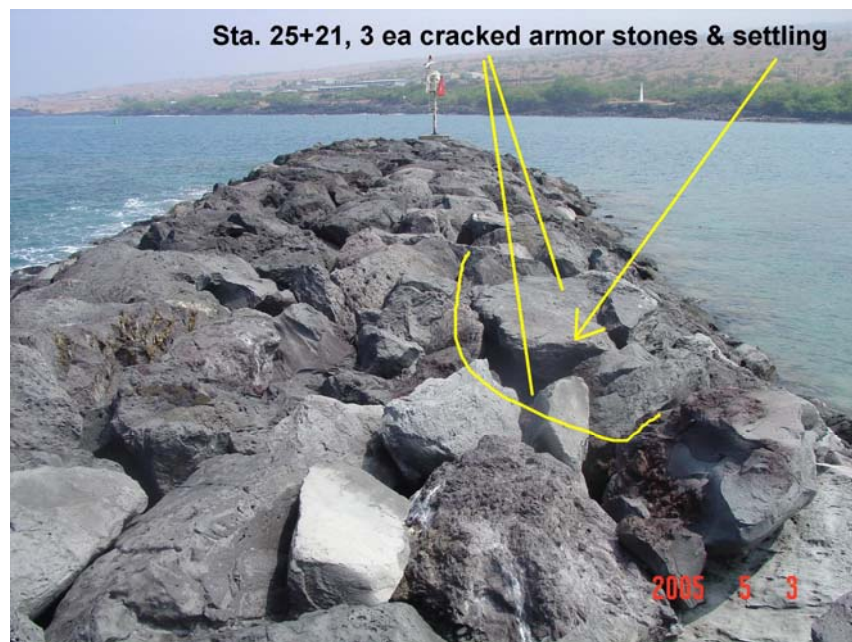
bbb. Sta. 25+21, CL, hinge stone settling and three cracked armor stones.

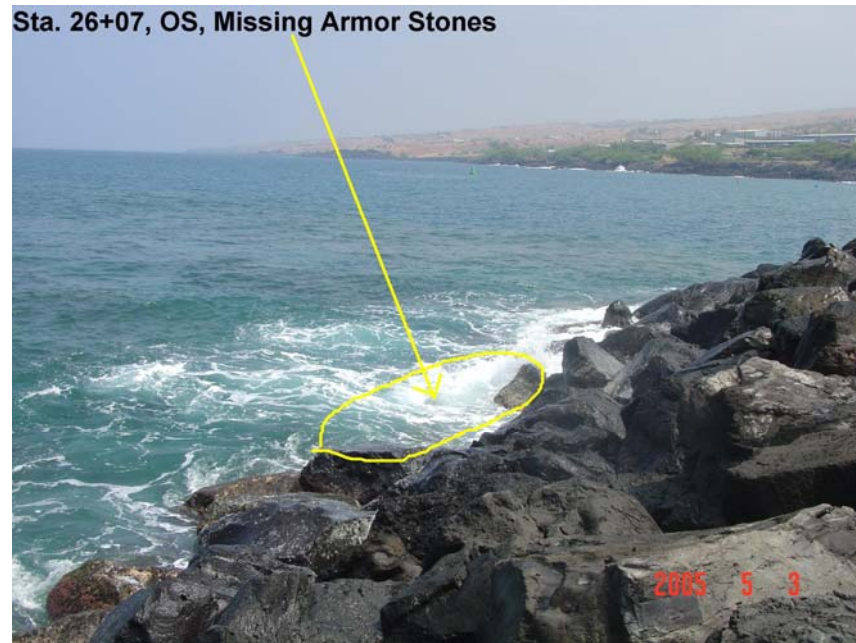
ccc. Sta 26+07, OS, Missing toe armor stone (6 ea.), monitor.

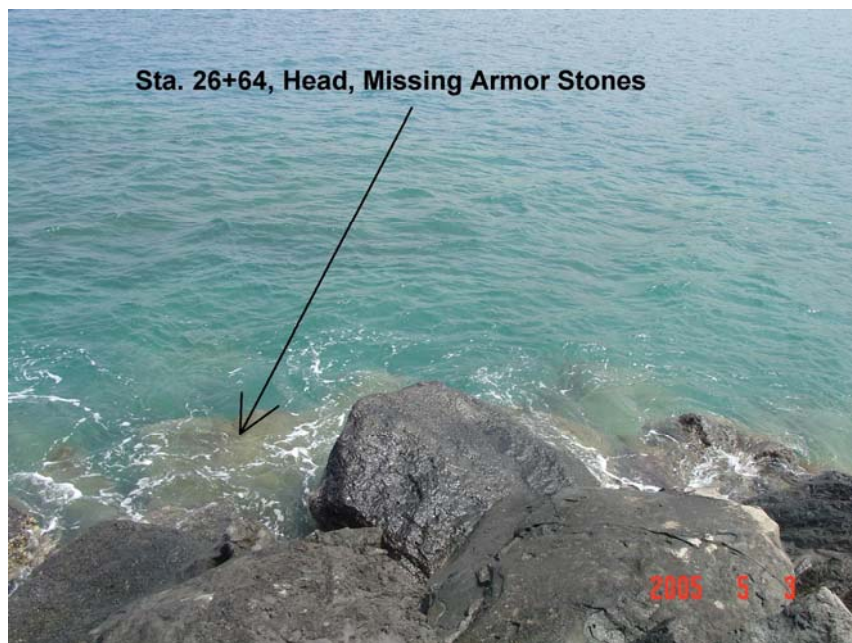
ggg. Sta. 26+64, Head, missing armor stones at the waterline.
